iwis-CCM: Chain Condition Monitoring System

The new intelligent control system for **continuous chain monitoring**

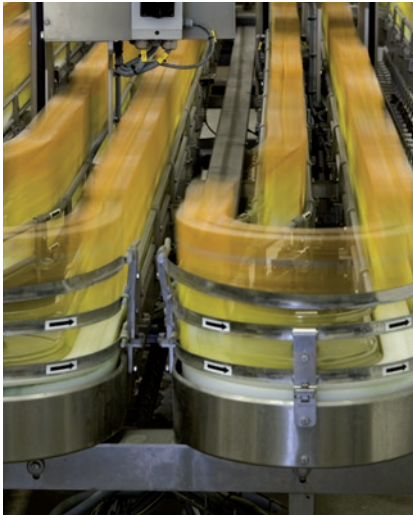
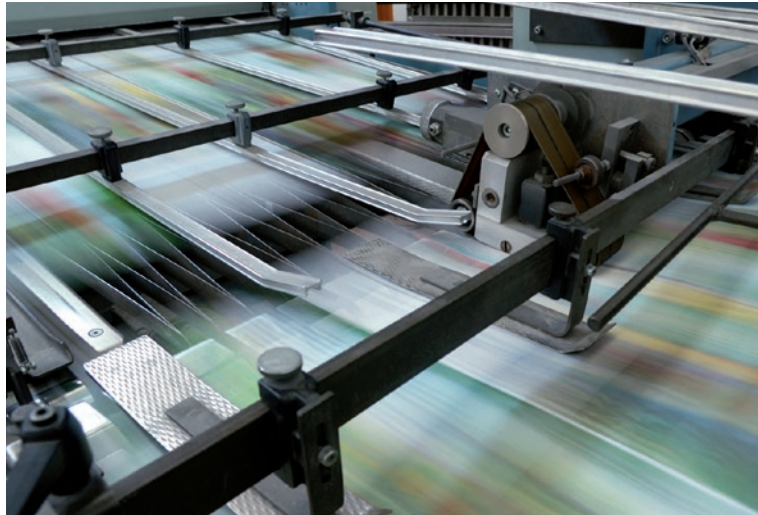
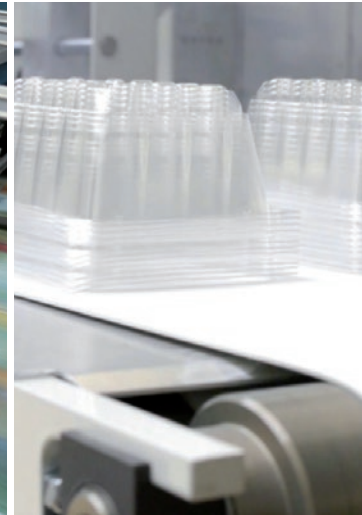
- The iwis **CCM System** can be integrated into numerous chain applications quickly and easily.
- Retrofitting to existing machines and systems does not require special chain attachments.
- The **CCM System** detects wear in a chain drive and warns maintenance staff about when and where countermeasures are necessary.
- LEDs integrated in the **CCM System** display operating status and wear status.
- Measurement results can also be transferred to a computer via USB connection and displayed in a special interface.
- Measurement takes place without direct intervention in the chain drive:
 - contact-free measurement
 - no additional deflectors or supports required
- Precise measurement results
- Independent of chain size
